title: INVESTIGATION OF MATERIALS FOR
SHIP-TO-SHORE LOW PRESSURE STEAM
HOSES

author: Thorndyke Roe, Jr.

date: July 1977

CIVIL ENGINEERING LABORATORY

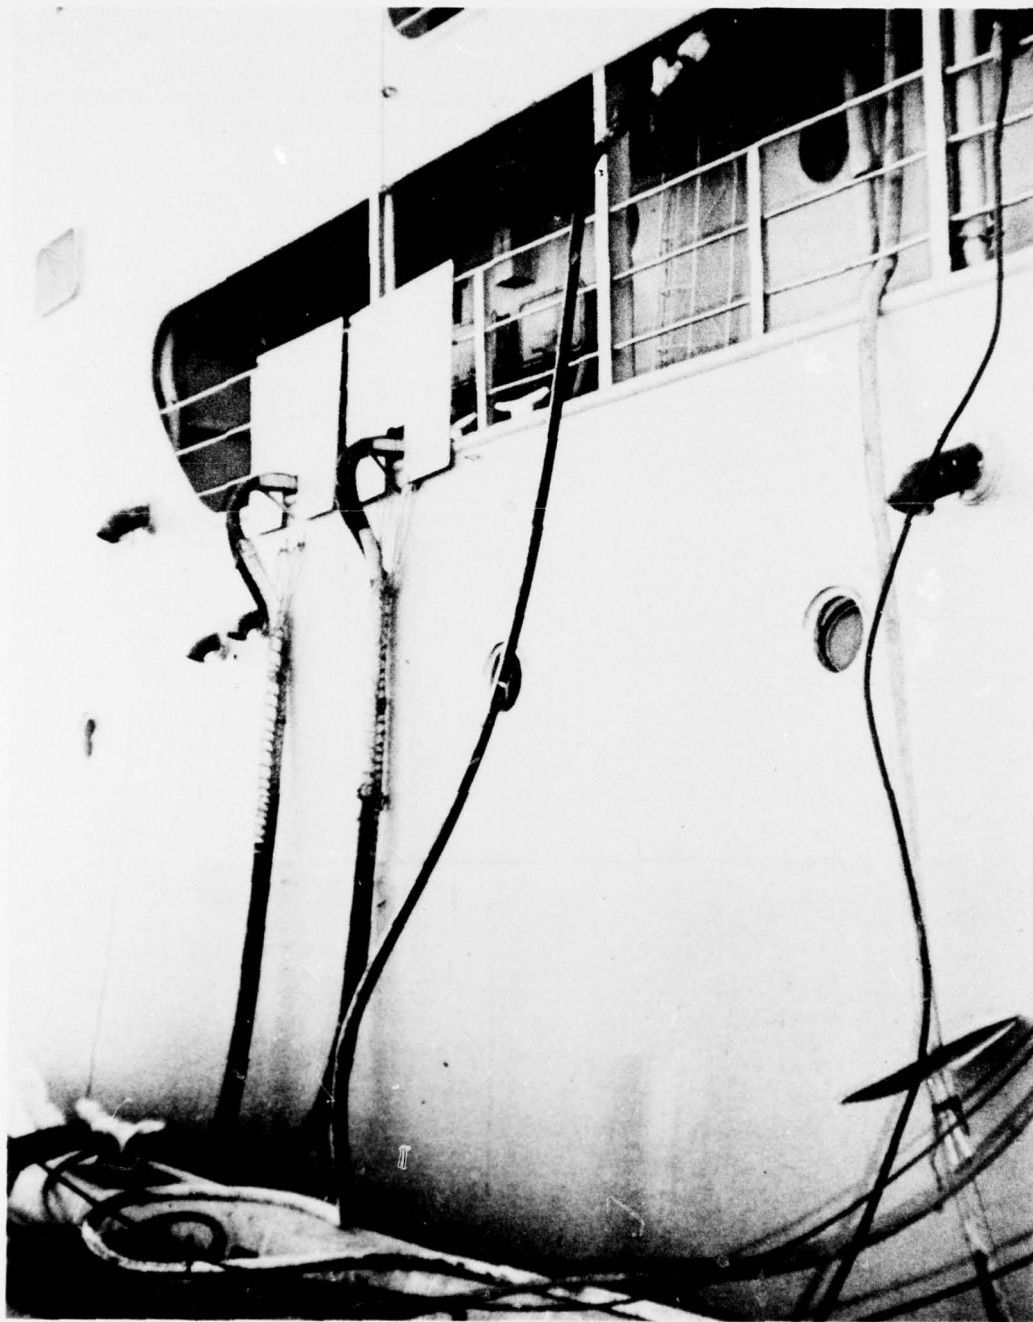
Abuse. Use plus abuse can greatly shorten the service life of a steam hose. Kinking, twisting, or hanging hose on a peg for storage can cause mechanical damage to it, and the amount of damage caused will increase as the hose components are affected by heat aging. Connecting a hose to a horizontal steam line at the ship causes a sharp (90 degree) bend in the hose and subsequent early failure.

Figure 1. Sharp 90-degree bends in steam hoses at ship's intake.

4. Use fittings where sharp bends are required. The minimum bending radius (inside) should be not less than ten times the outside diameter of the hose. Where the intake fitting is flush with the side of the ship, a fitting should be available so that the steam hose can be connected in a downward direction. Figure 1 shows a 90-degree hose bend at a horizontal intake where early failure occurred (see Appendix B).

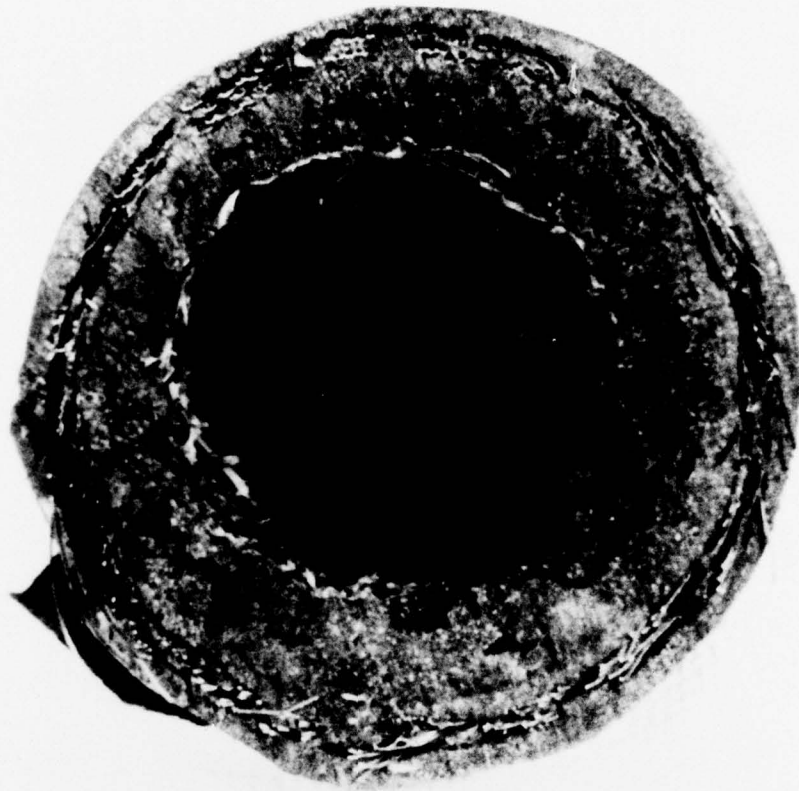
These hoses were removed from service temporarily in January 1977 when the USS Norton Sound was undergoing refitting at Long Beach. One of the glass braid-lined rubber hoses had sustained abrasion damage on one end after 112 days of intermittent service. When the damaged section was cut off so that the fitting could be reinstalled, it was found that the glass braid liner had deteriorated; thus, the hose had to be discarded (Figure B-1). One 2-inch stainless steel-lined rubber hose had sustained cover damage after 140 days of intermittent service. This occurred where the hose made a sharp 90-degree bend adjacent to the ship's inlet line (Figure B-2). Because this hose cannot be field-repaired, it was removed from service.

Figure B-1. Deteriorated glass braid-lined steam hose.

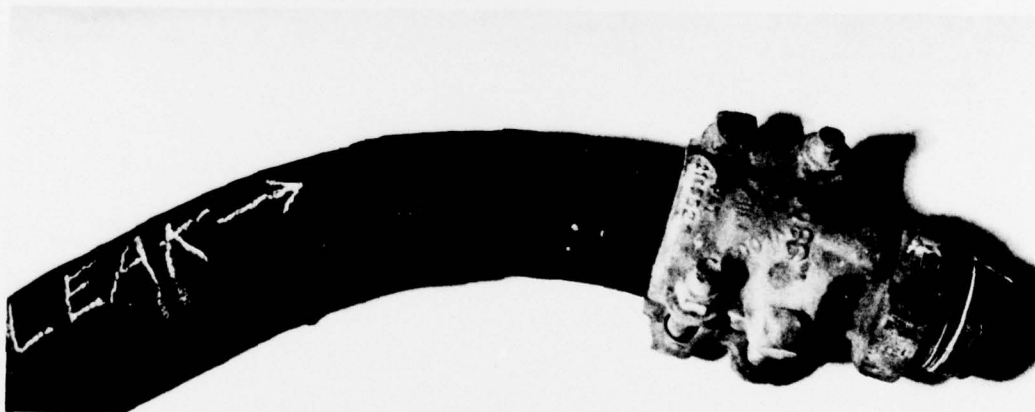
Figure B-2. Cover damage on 2-inch stainless steel-lined rubber hose caused by sharp 90-degree bend at ship's intake.
